Manhole Inspection Summary

Manhole # S25GG1022MH

Location Address: **4101 FALLS RD**

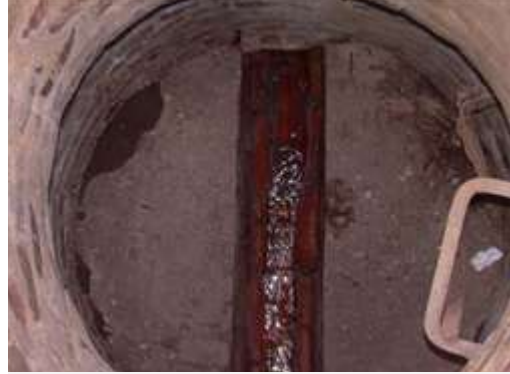
Top View

Corroded steps. Bench debris.

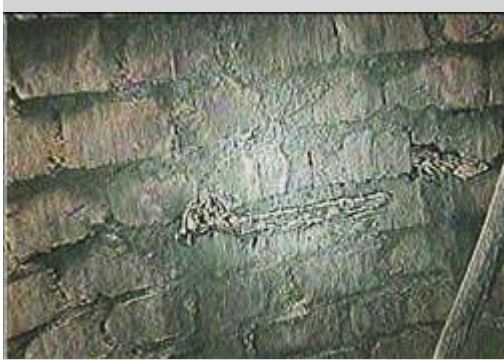
Defect

Corroded and missing steps. Corbel and Barrel deterioration and infiltration.

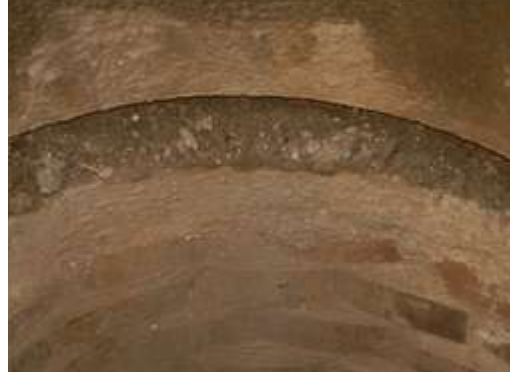
Defect

Frame leaks. Adjustment infiltration.

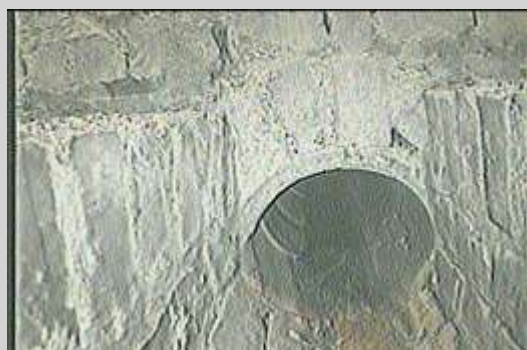
Pipe Out @ 12 O'Clock

Barrel deterioration and infiltration. Channel deterioration.
